US Army Armor Human Research Unit Fort Knox, Kentucky

Human Factors Evaluation of the Tank, Combat Full Tracked: 105mm Gun, M60

Donald F. Haggard Albert R. Wight

Consulting Report February 1961

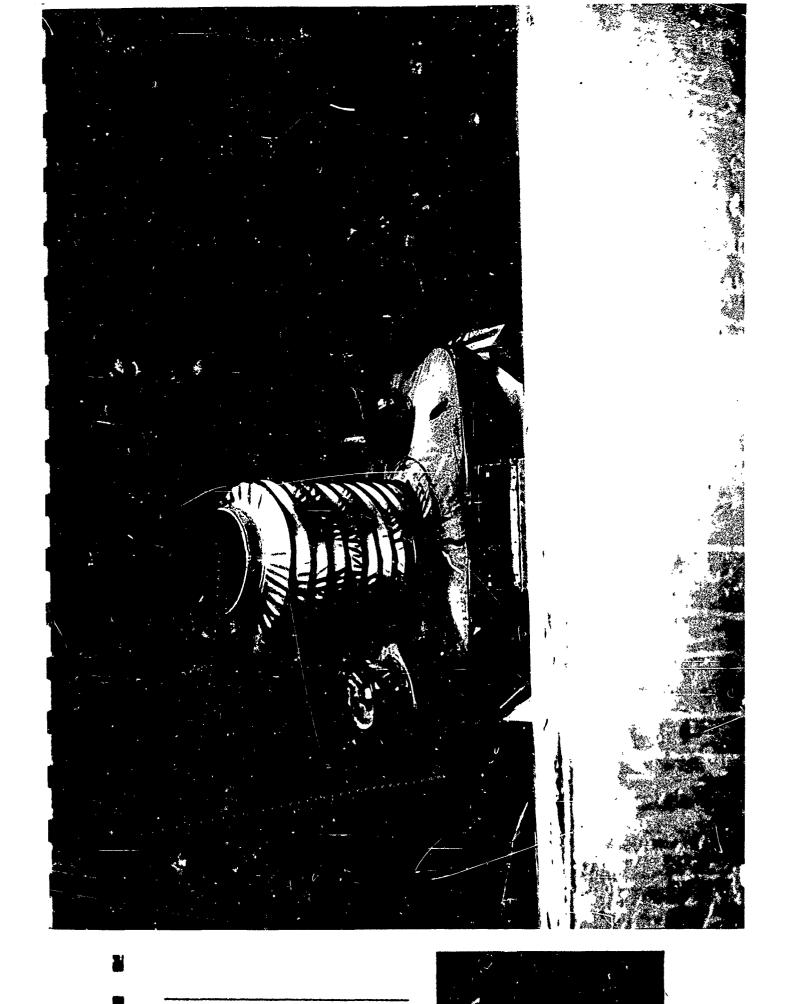
Figure 6

Minimum Visual Angle over Front of Hull, Showing Interference of Periscope with Vision of Driver

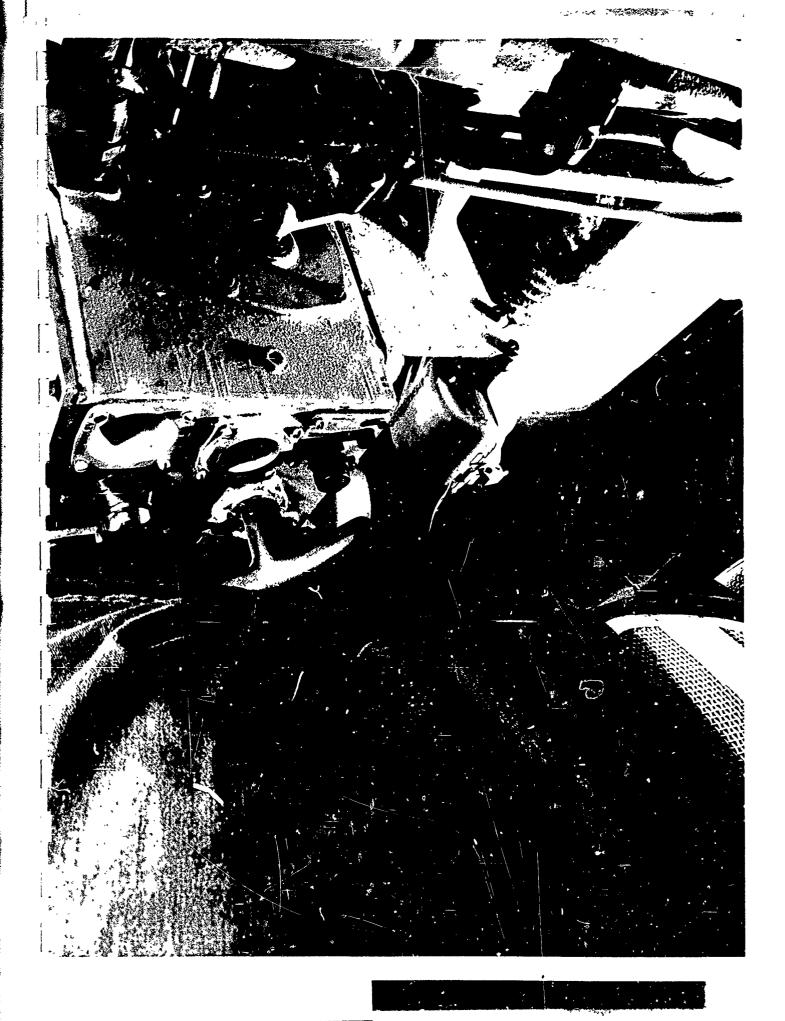
the gunner's elbow locks against the ammunition selector handle. (See Figure 16.) This condition forces the gunner to operate with his elbow lowered, increasing the difficulty of turning the crank smoothly and precisely. Since the space available precludes relocation of the assembly, a different plane of movement should be adopted.

Figure 16:

Interference of Ammunition Selector Handle with Gunner Operation of Hand Traversing Assembly It is difficult to turn through the vertical plane and at the same time apply force in the horizontal plane. The force required increases as the crank stiffens with use. A large hand knob with a detent button would greatly improve the speed and ease of operation.

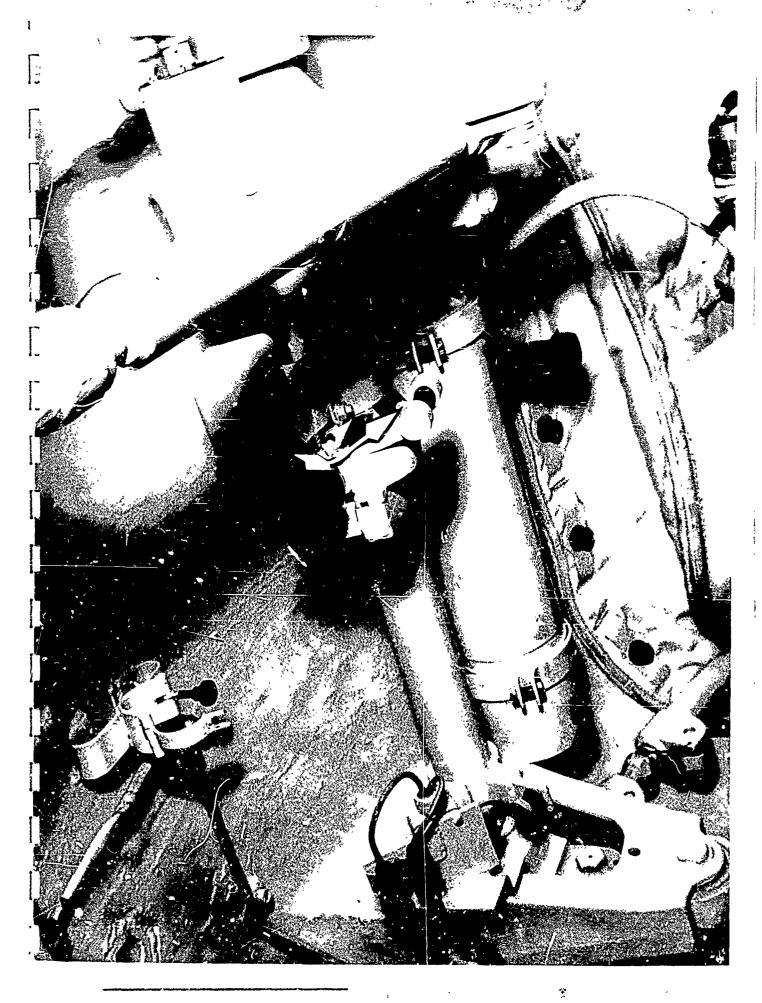
Figure 17:
Interference of Mirror with Lighting for Level Vial of Elevation Quadrant
